RE: Hazelwood Park Trees

We have completed the tree risk mitigation assessment for the phase 1, 2, and 3 trees at Hazelwood Park. Trees were observed in January 2020 and located in the areas defined on the Hazelwood Park Tree Removal Phasing Plan provided by The Watershed Company. The City of Newcastle requested these services to determine measures to abate the current risk potential presented by the subject trees. American Forest Management did not perform a tree risk assessment on the subject trees.

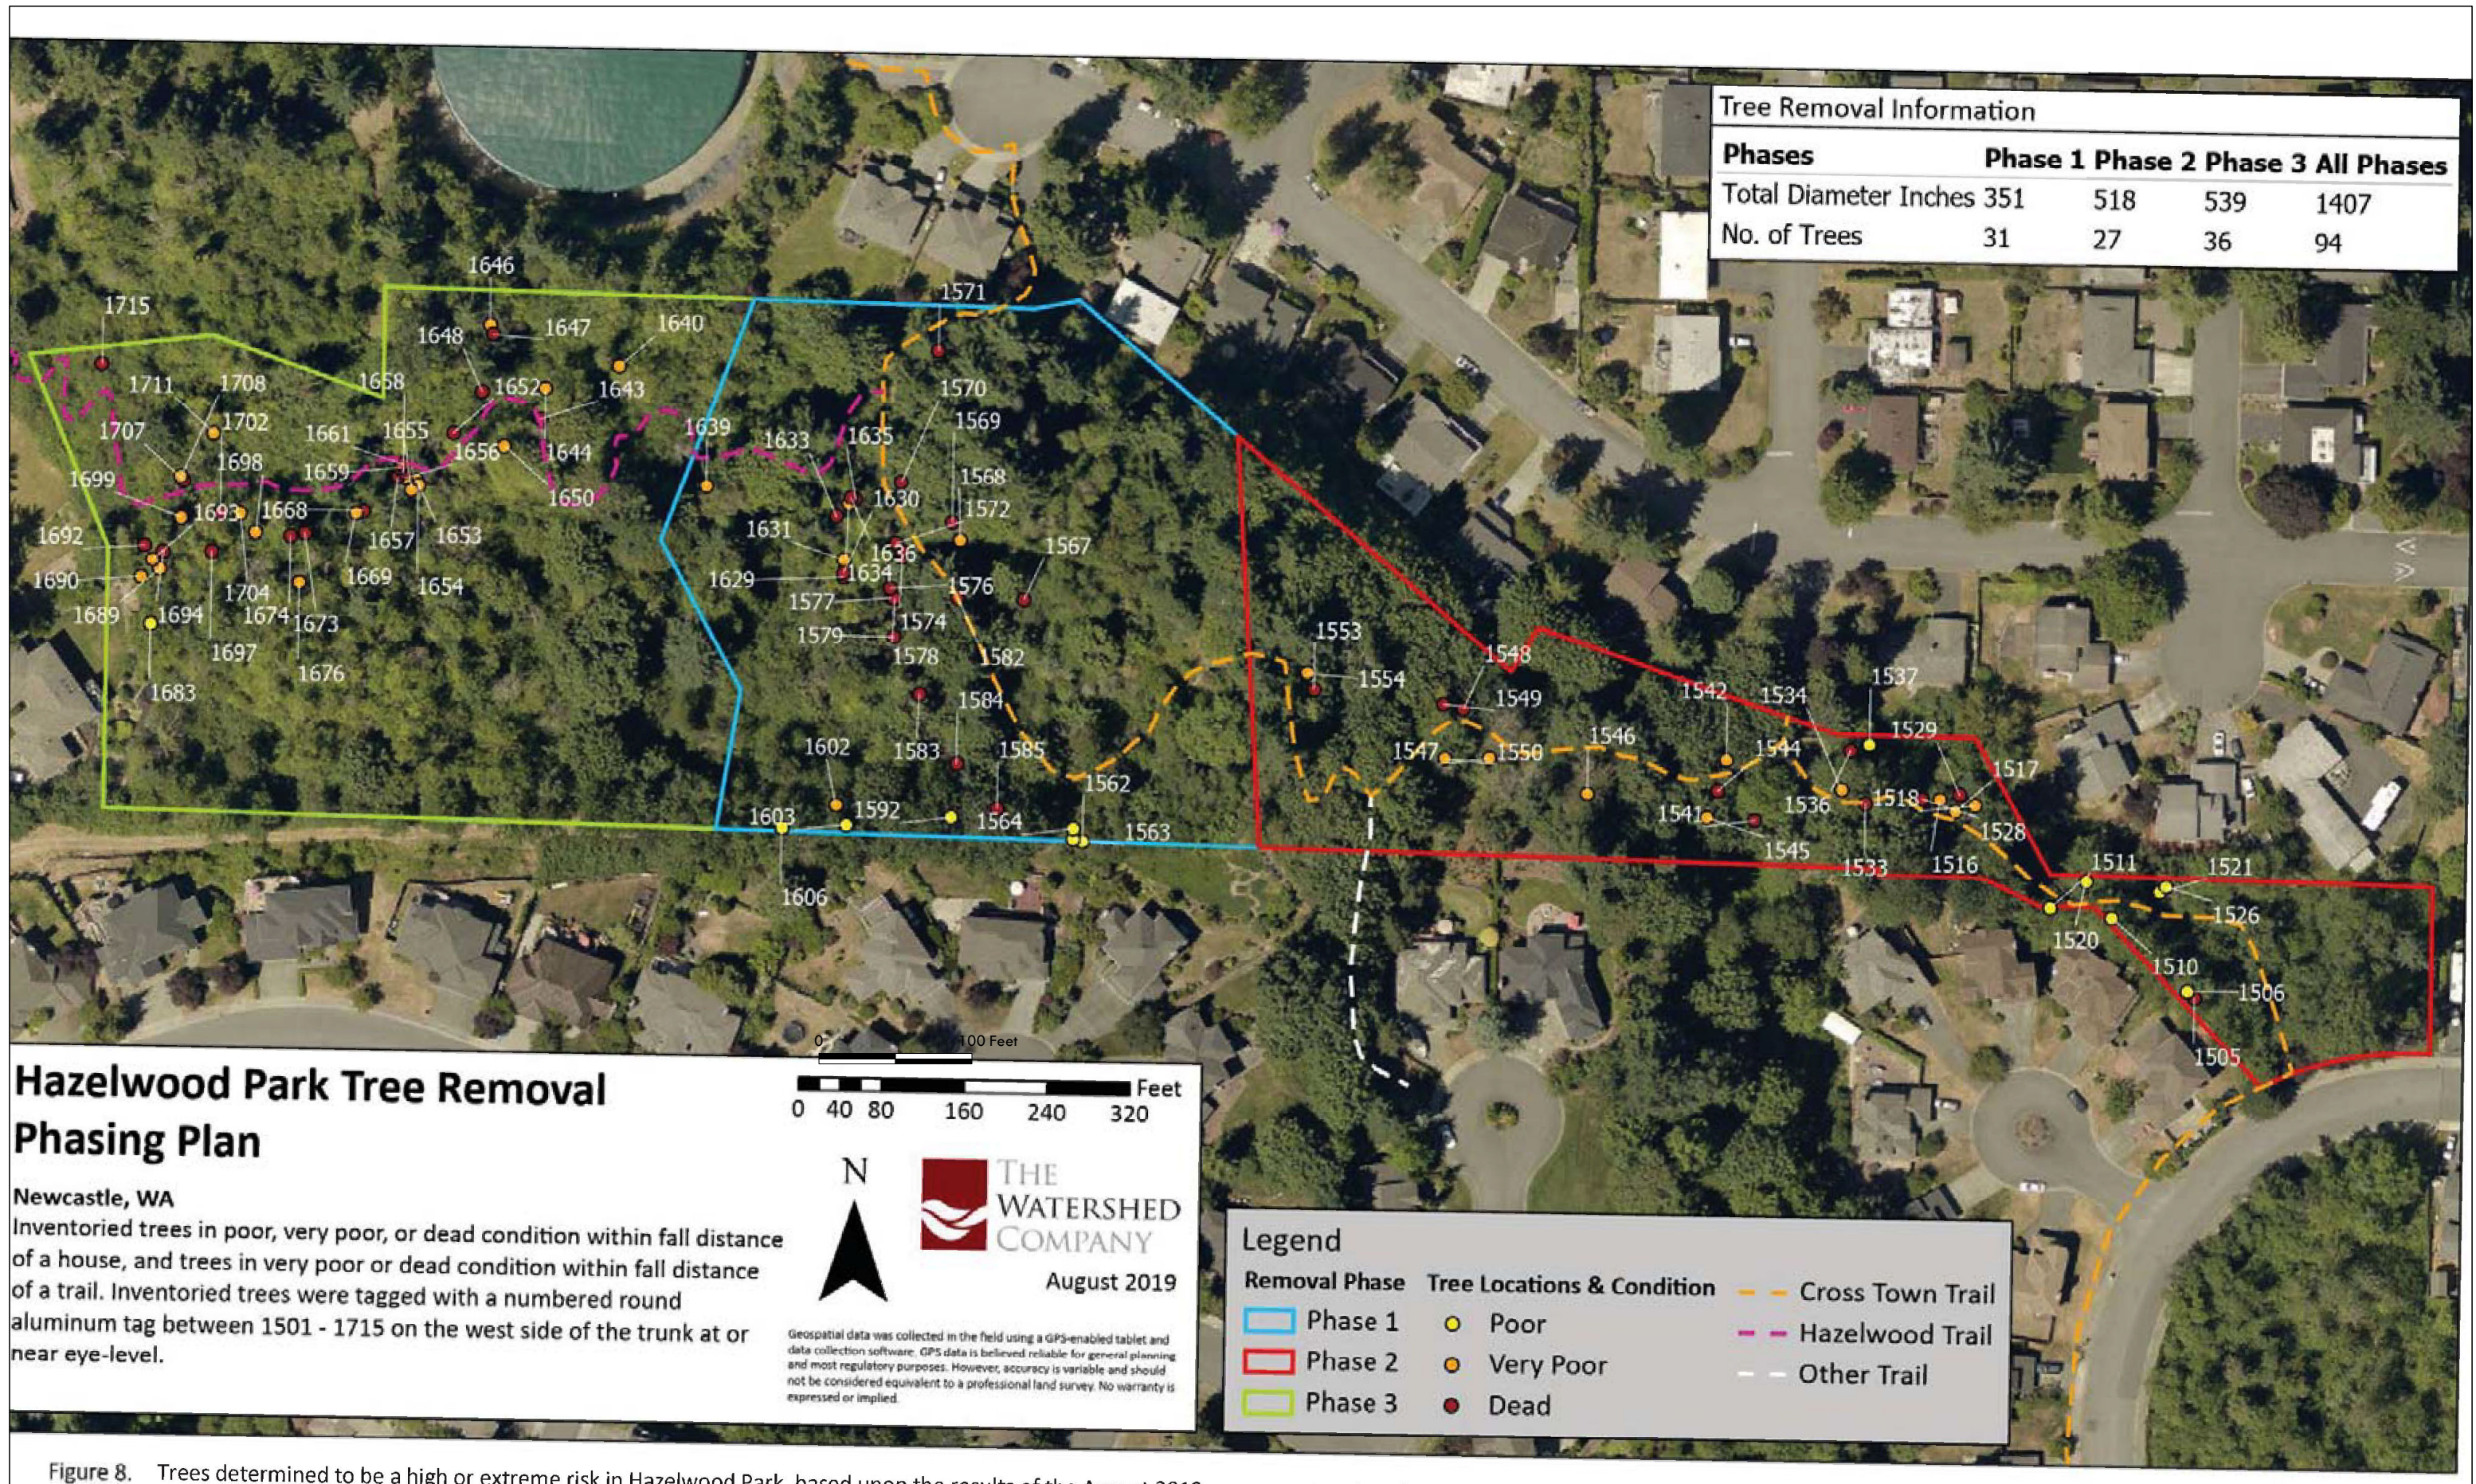
Figure 8. Trees determined to be a high or extreme risk in Hazelwood Park, based upon the results of the August 2019 assessment.
