DEVELOPING A STORM PIPE REHABILITATION PROGRAM: S-038

June 1, 2020

Surface Water Management Division

Public Works Department

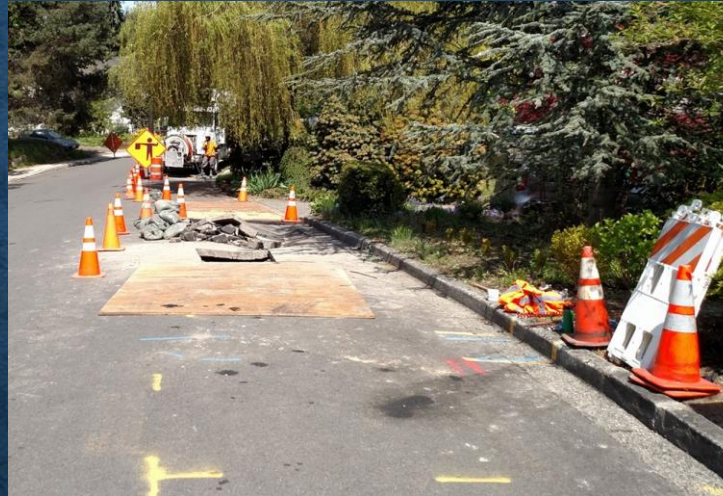
May 2017 sinkhole

\$46,000 to repair

Caused by catch basin that was never brought to grade and roots in pipe
