# S-017 Newcastle Railroad Embankment Project

# S-017 Background

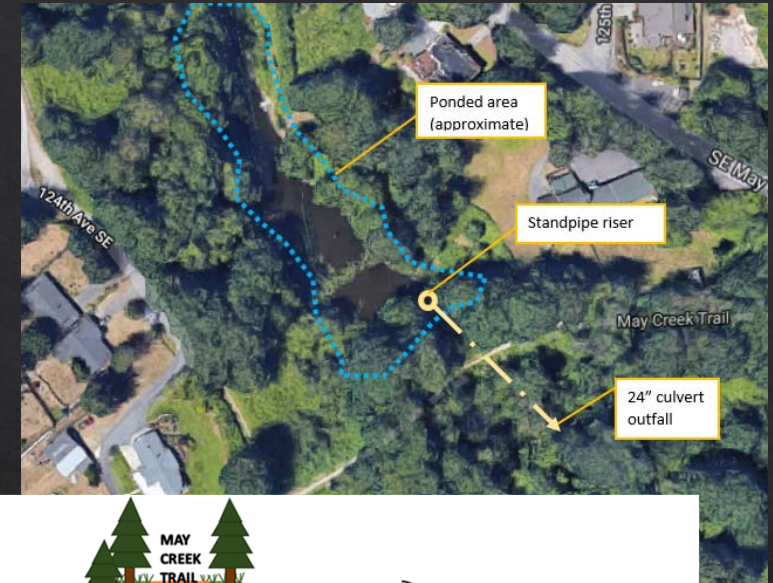
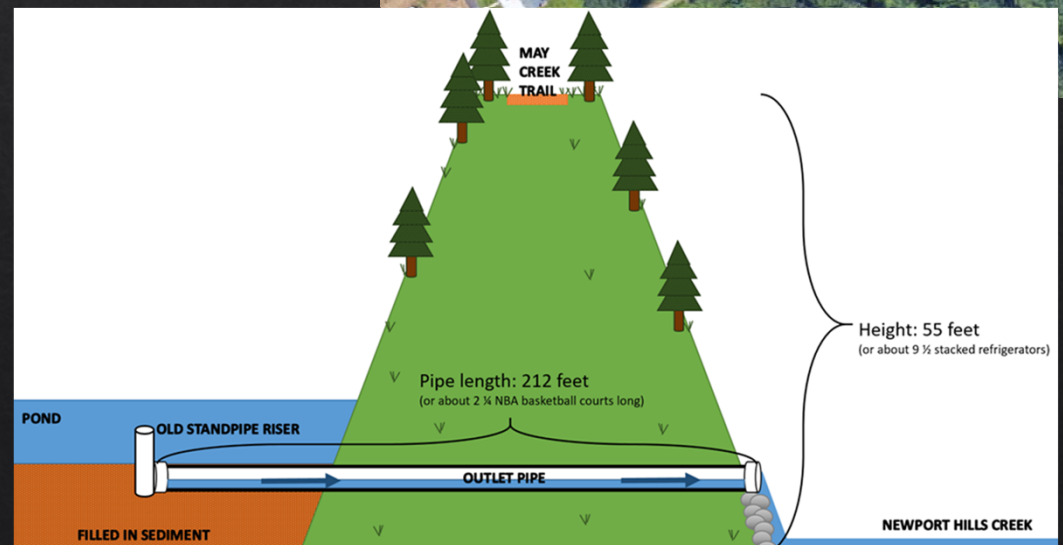
# Railroad Embankment Details

- ◆ The embankment is 55 feet tall and 150 feet long. May Creek Trail is located on top of the embankment.
- ◆ Newport Hills Creek flows under the embankment in a long culvert. A vertical pipe, called a standpipe, was attached to the upstream end of the culvert at least 50 years ago, creating a pond.
- ◆ The Railroad Embankment is considered a High Hazard Dam, based on its size and condition.
- ◆ At the top of the embankment (at dam crest), the dam holds 120 acre-feet of water (the equivalent to 60 Olympic sized swimming pools).

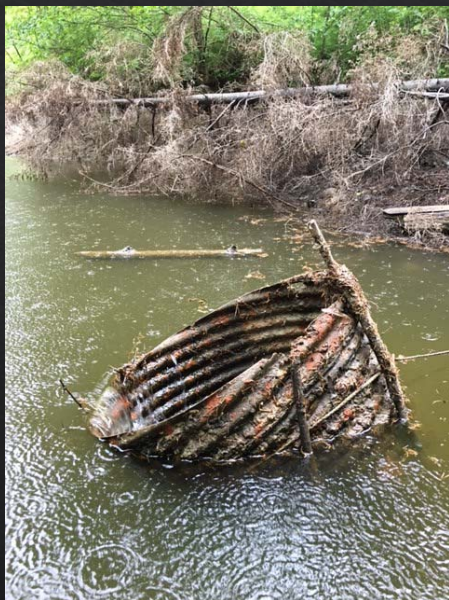
# Issues with the Railroad Embankment

- ◆ In 2018, the riser began to exhibit operational issues and the outlet of the dam was only flowing intermittently.

- ◆ The Railroad Embankment was also given a Poor Condition rating by the Washington Department of Ecology Dam Safety Office.

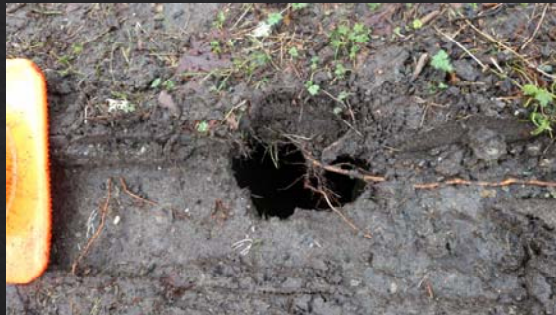
# Rising storm waters

- ◇ During the December 2019 and February 2020 storm events, the riser was not flowing at all.
- ◇ Water level rose 15' in a few days, sinkholes developed at the dam crest.

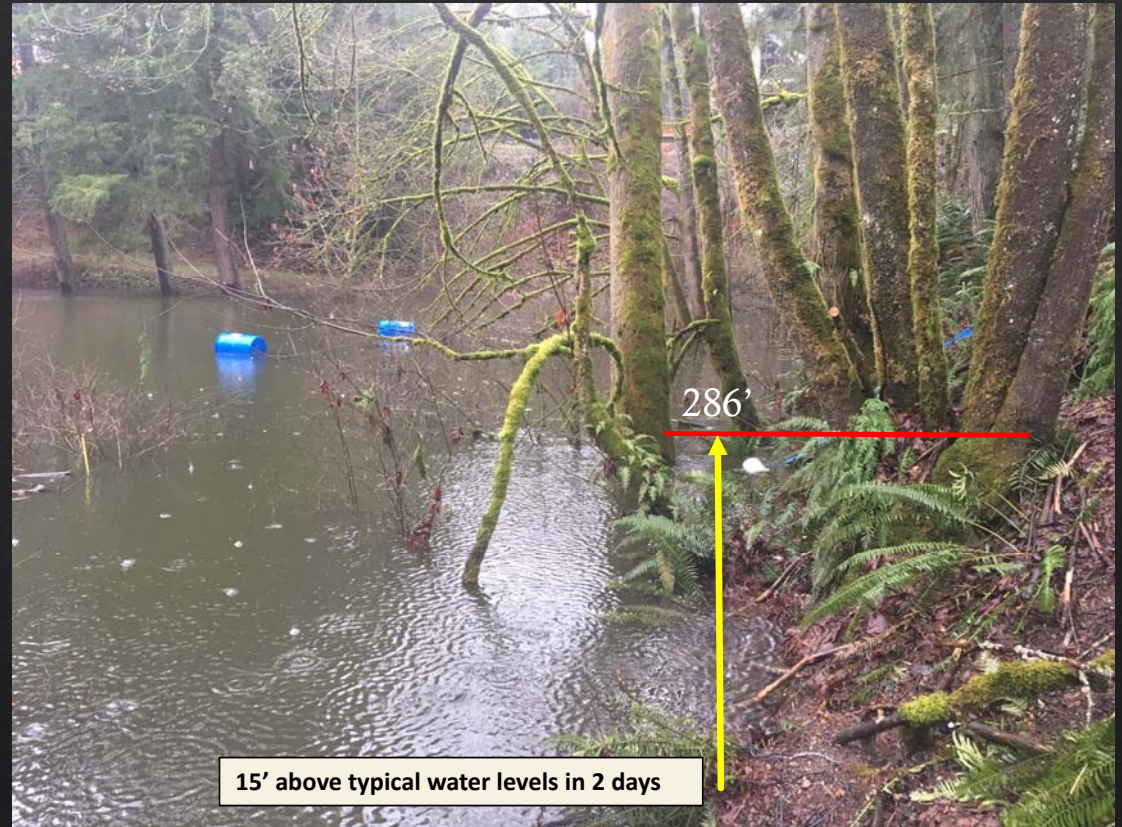
- ◇ 3 pumps running 24 hours/day could not keep up with rising water levels.

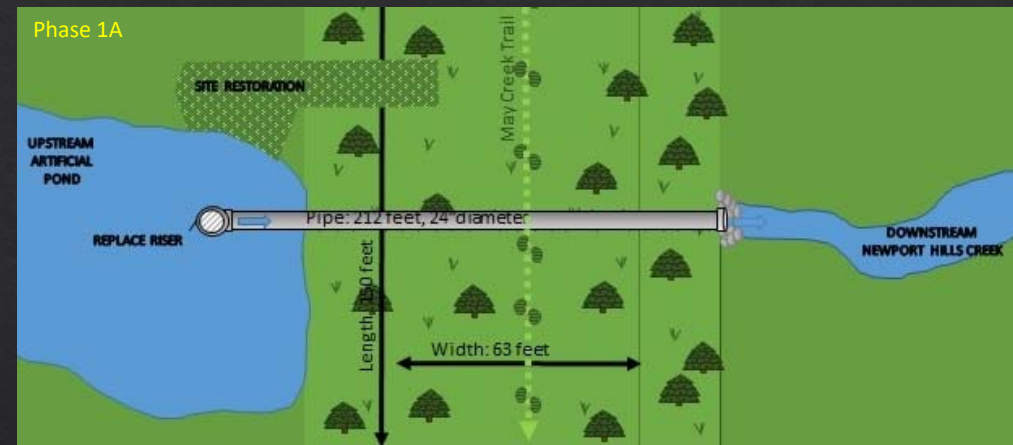
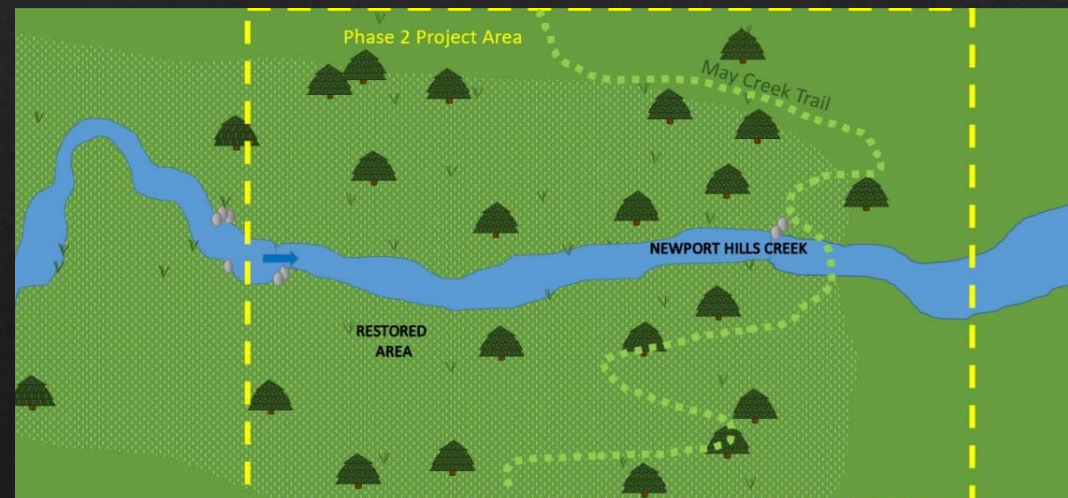
# S-017 Project Planning

- ◆ The City evaluated options for the embankment and has been working with numerous regulatory agencies and stakeholders.
- ◆ To reduce flood hazard at the embankment, the City determined that the project would consist of 2 phases:
  - ◆ Phase 1: Removing or replacing the riser
  - ◆ Phase 2: Removing part or the entire embankment
- ◆ Project goals:
  - ◆ Reduce or eliminate flood hazard and environmental damage from a dam breach/failure
  - ◆ Remove the embankment from the DSO inventory of high hazard dams
  - ◆ Restore fish passage to Newport Hills Creek

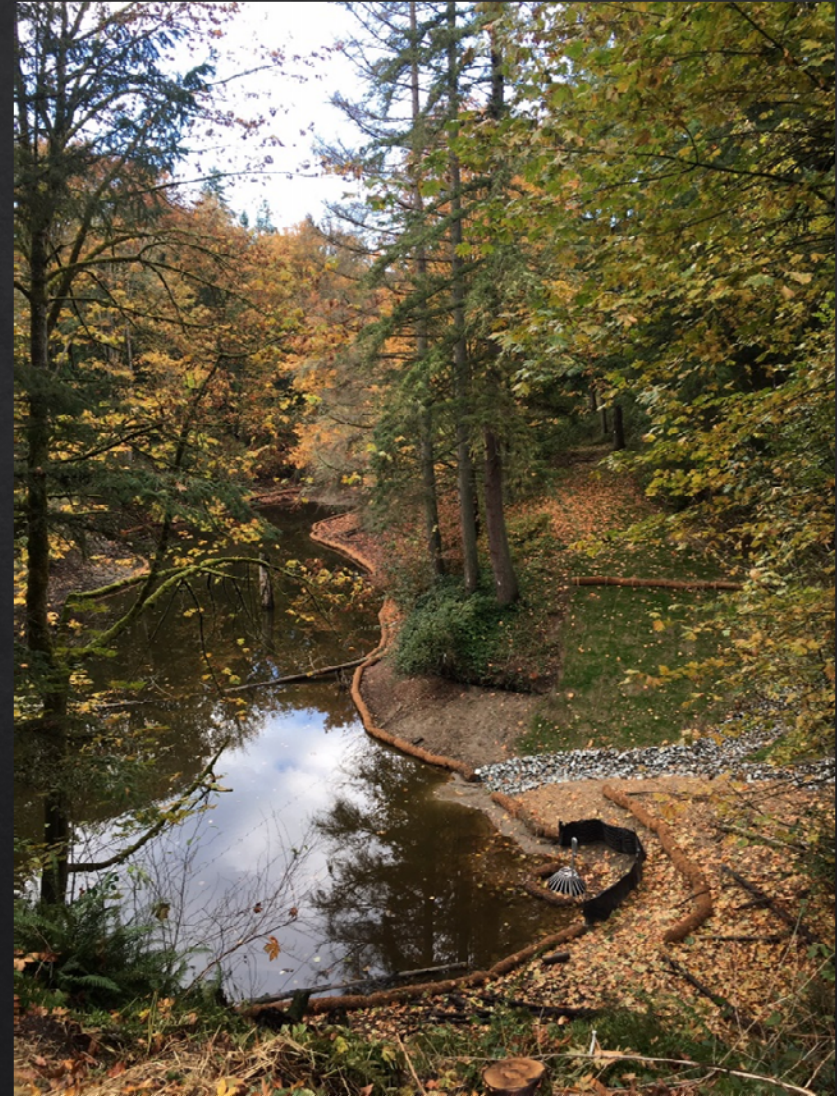
# S-017 Phase 1A: Completion

- ◇ Completed October 2020
- ◇ Design Engineers: Osborn Consulting, Inc.
- ◇ Survey: Axis Survey
- ◇ Geotech: ZipperGeo
- ◇ Contractor: Nordvind Company, LLC
