DEVELOPING A STORM PIPE REHABILITATION PROGRAM: S-038

June 1, 2020

Surface Water Management Division

Public Works Department

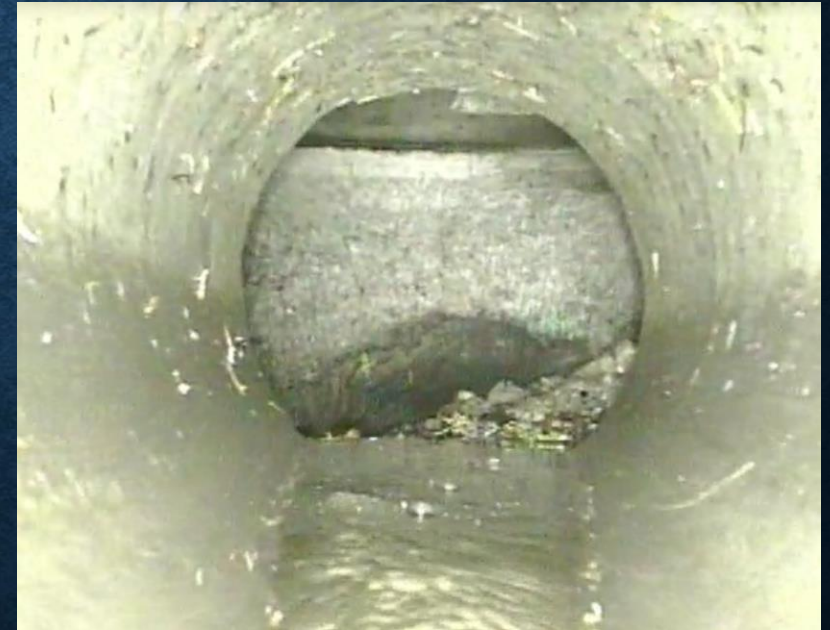
May 2017 sinkhole

\$46,000 to repair

Hours and hours for storm crew

Caused by catch basin that was never brought to grade and roots in pipe
